**FBVA - B E R I C H T E**  
**Schriftenreihe der Forstlichen Bundesversuchsanstalt**

**Nr. 36**

**1988**  
**BEITRÄGE ZUR WILDBACHEROSIONS- UND LAWINENFORSCHUNG**  
**ODC 116:384:971**

**CONTRIBUTIONS TO RESEARCH ON TORRENT EROSION AND AVALANCHES**  
**ESSAIS SUR LA RECHERCHE D'ÉROSION TORRENTIELLE ET DES AVALANCHES**

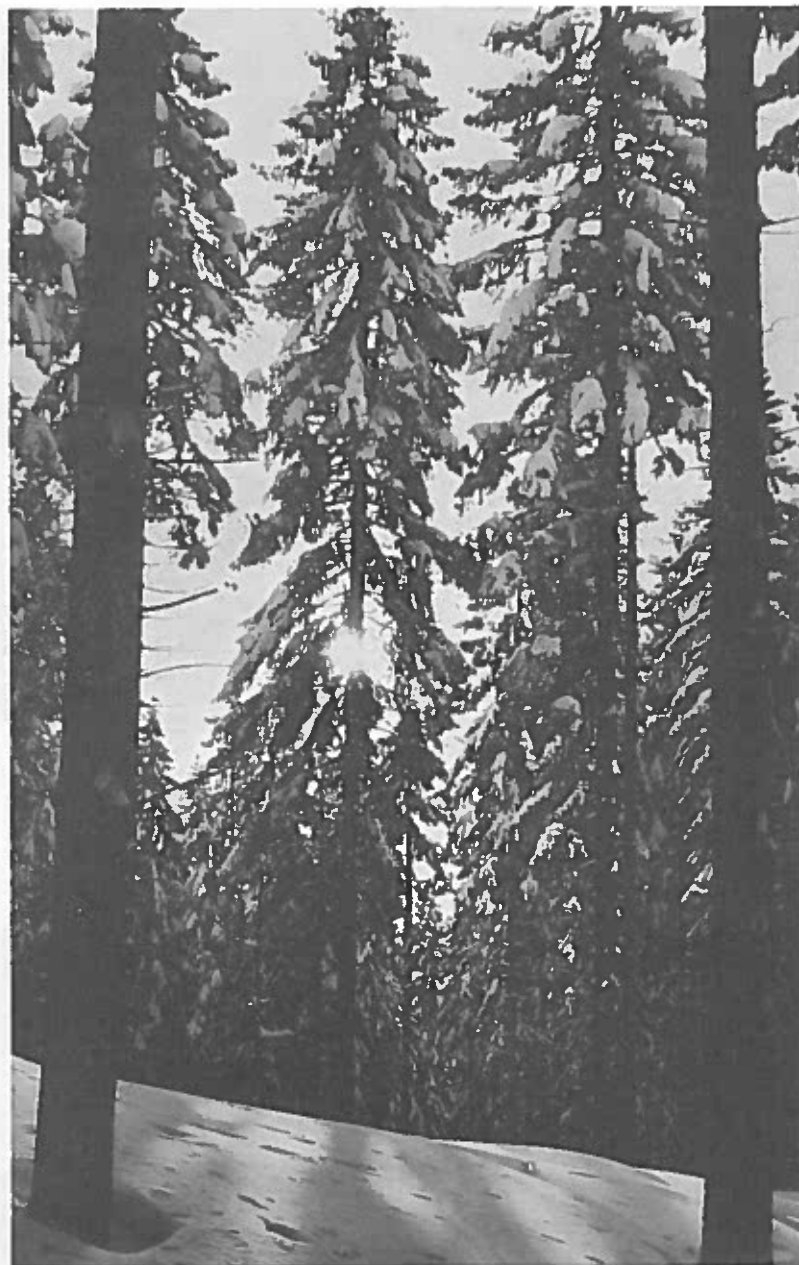
Fig.1 The spruce stands in the experimental watershed at Malá Ráztoka twenty years ago

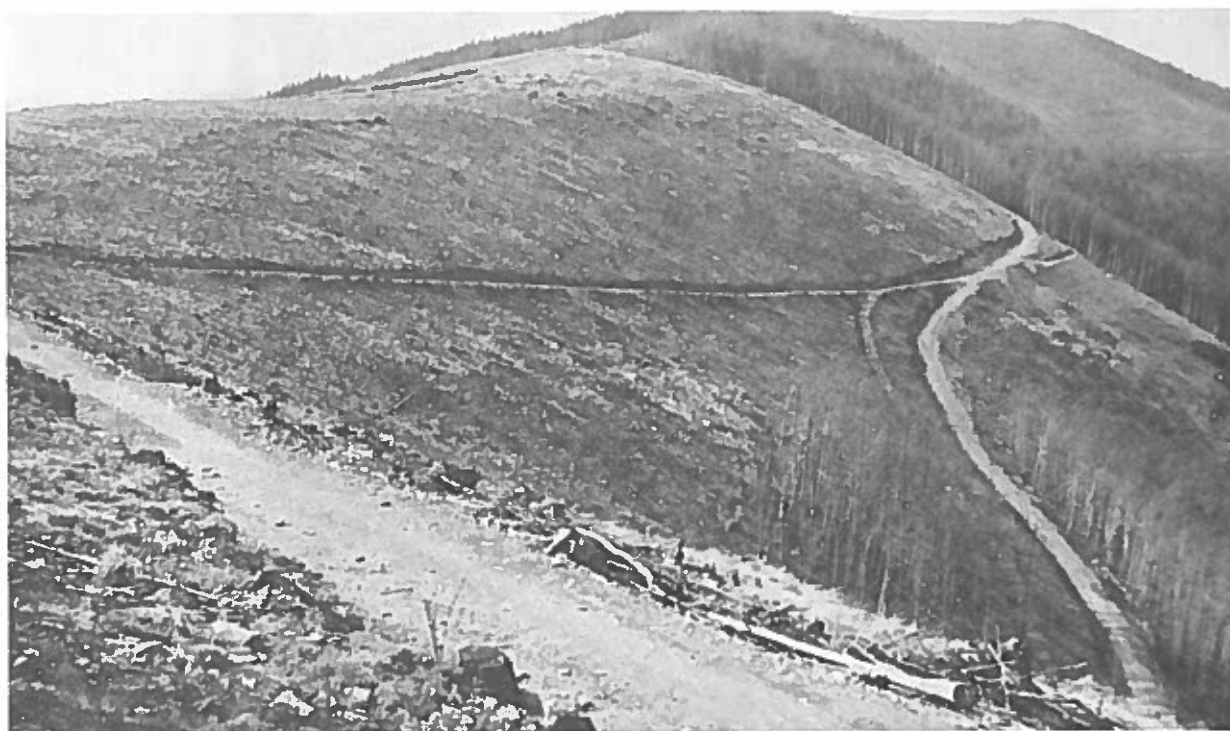
Fig.2 The beech stands killed by air pollution

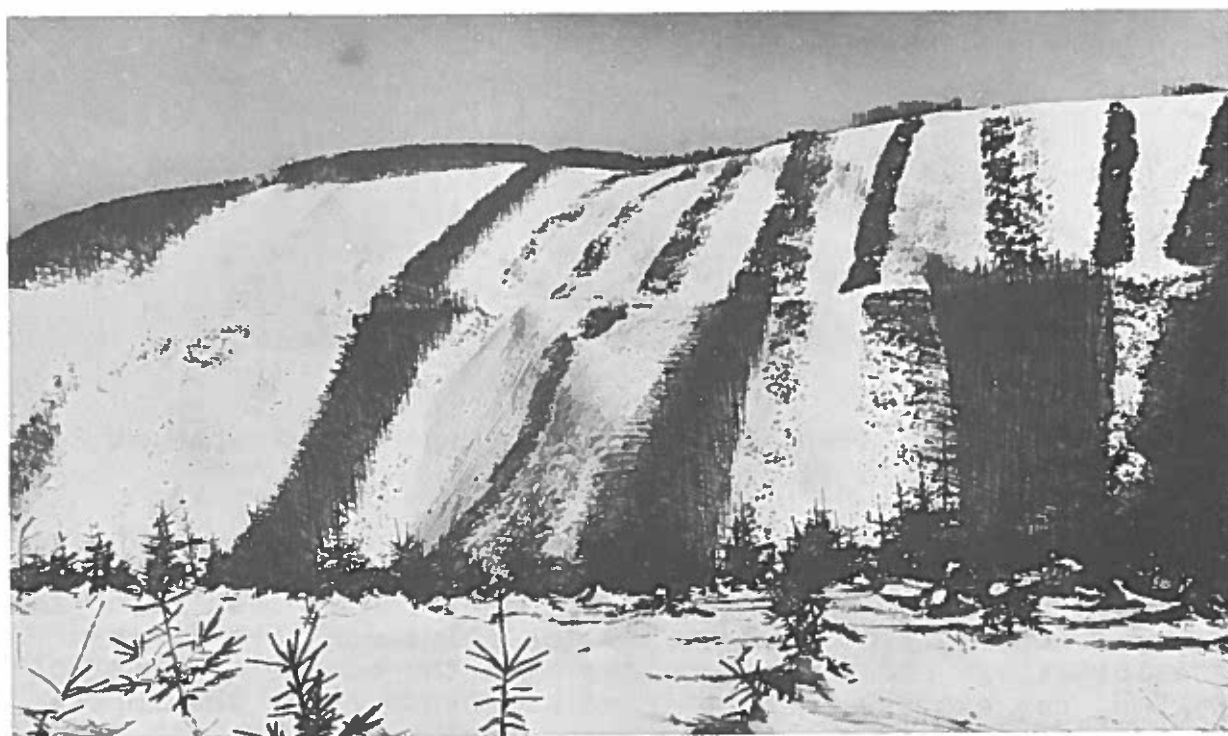
Fig.3 The present view of the forest renewal in the experimental watershed at Malá Ráztoka
